## Tree Protection Report

**2189 Stunt Road,  
Calabasas, CA 91302  
(Los Angeles County)**

July 25, 2020

Prepared by:  
Carl Mellinger Consulting, LLC  
P.O. Box 1135  
Pacific Palisades, CA 90272  
(310) 454-6915  
© 2020 Carl Mellinger - All rights reserved

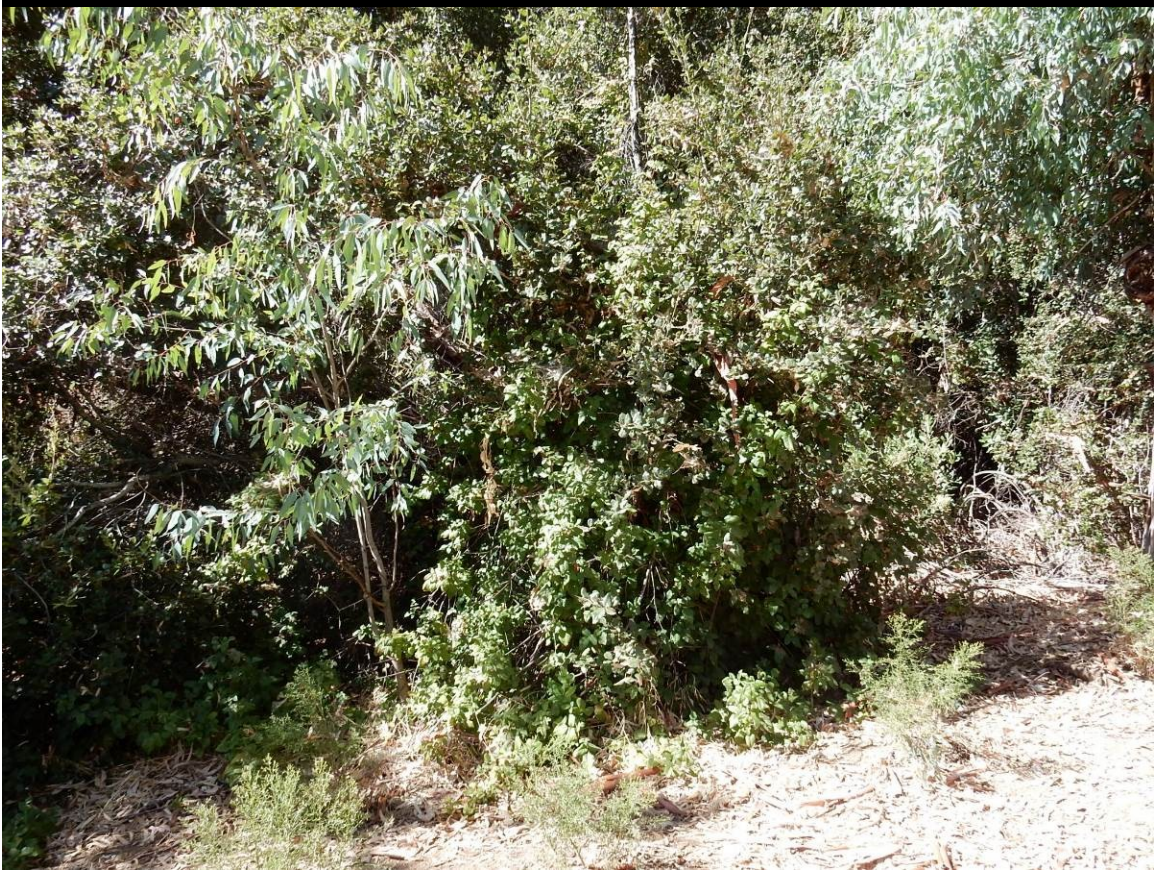
Tree #7, coast live oak (protected oak).

4. Prune tree #7 to reduce end-weight. A pruning permit may be needed from a county forester.

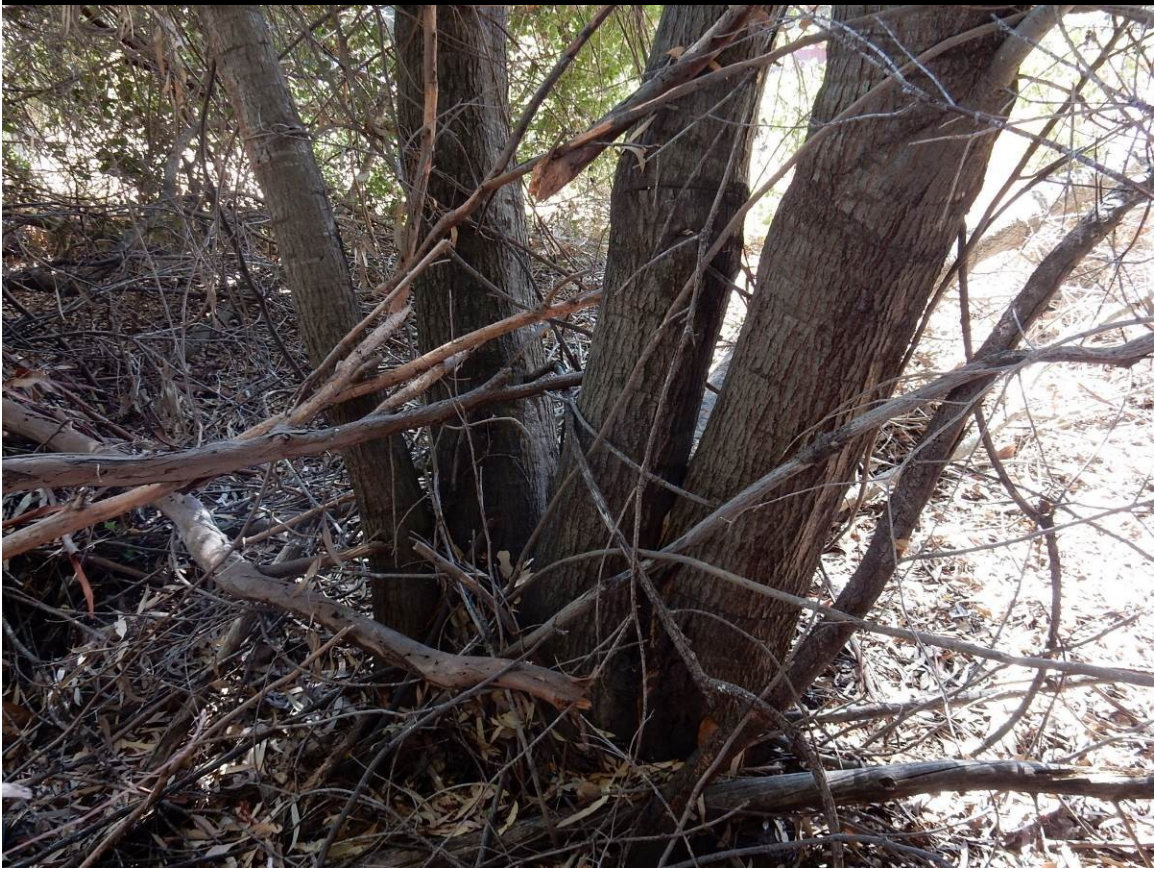
Tree #12, coast live oak (protected oak).

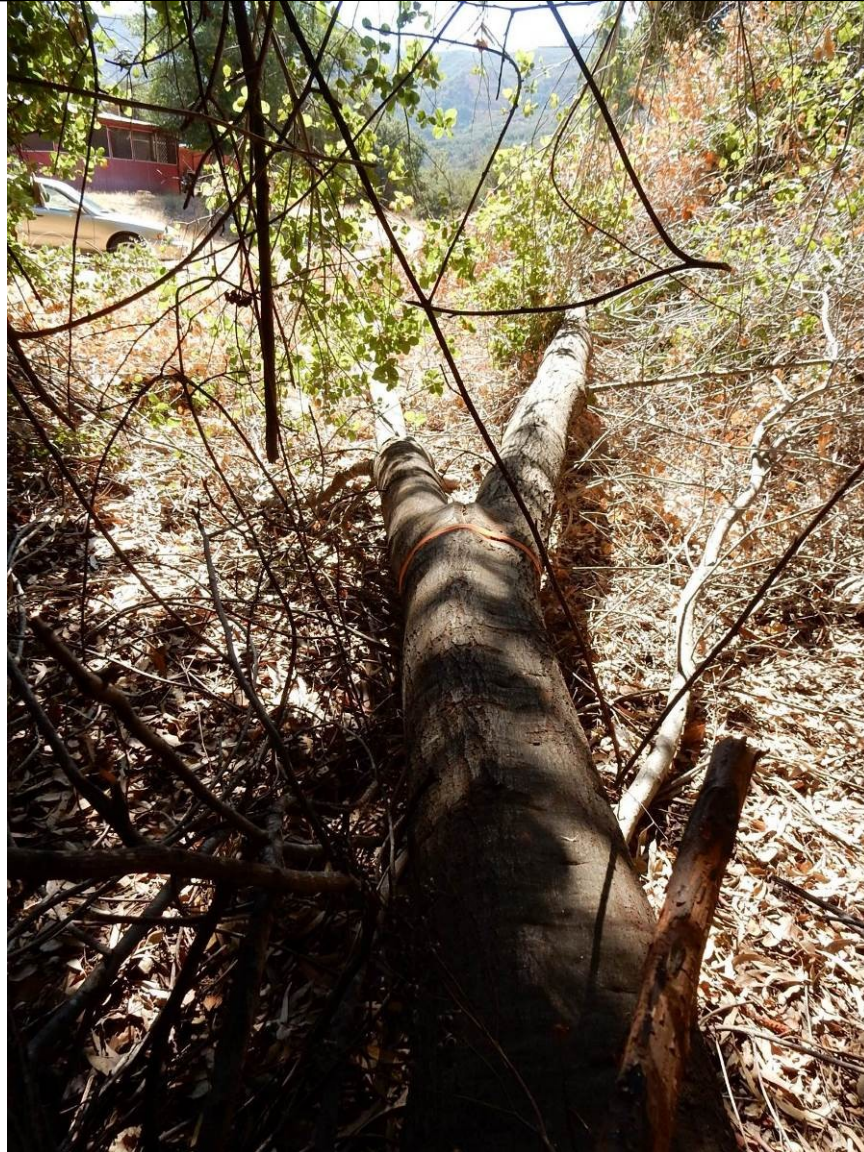
The failed trunk on tree #12 had a large amount of included bark at the base.

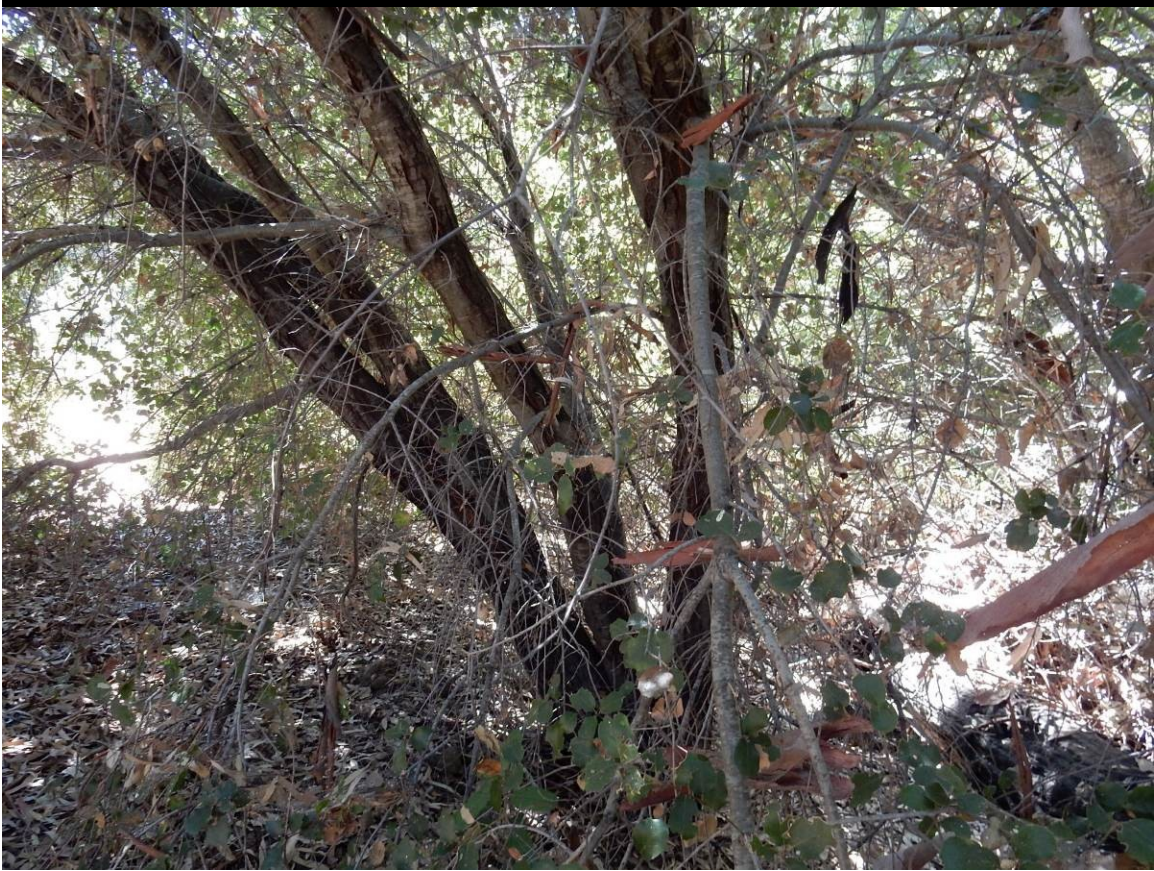
Tree #17, coast live oak (protected oak).

1. Soil buildup against the root crown of trees #17, and 32-35 should be removed manually without damaging bark. Trees where root crowns have been cleared should be re-inspected by the project arborist for disease or structural issues.

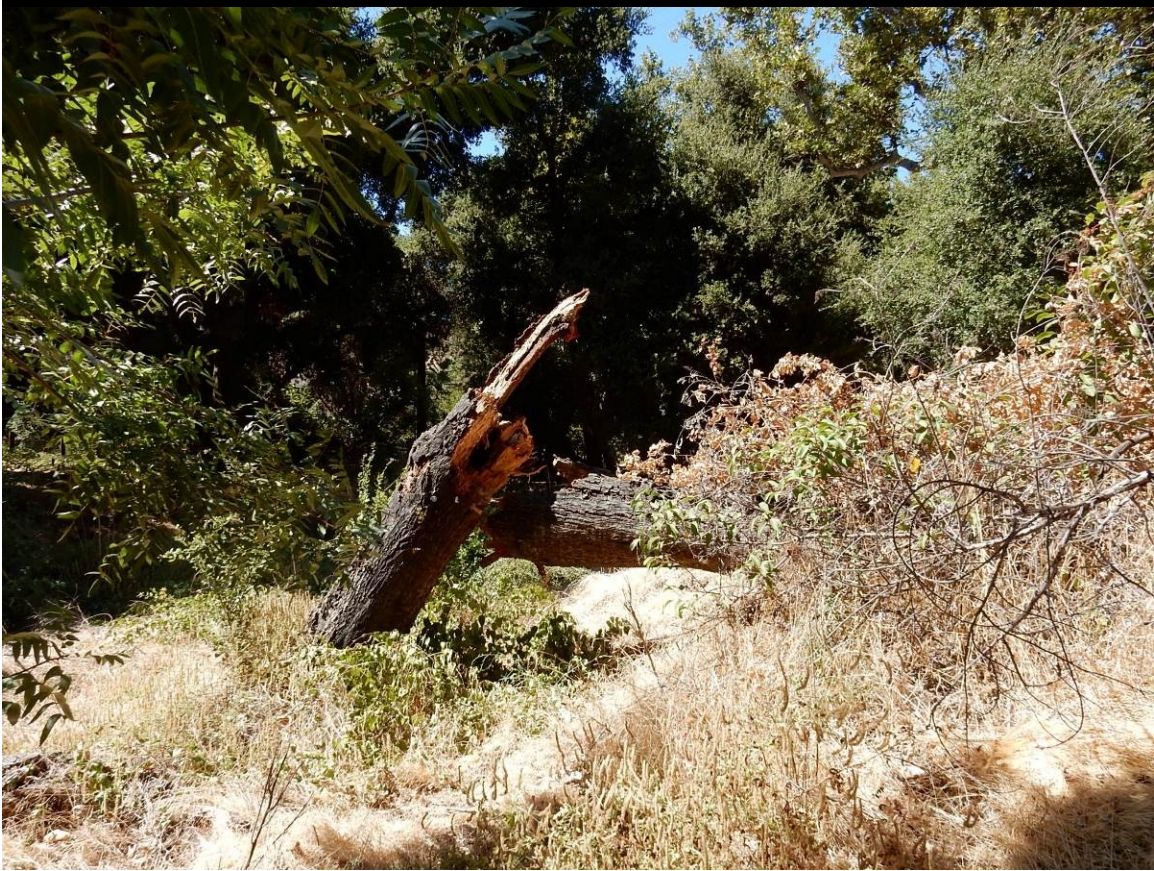
Tree #19, coast live oak (protected tree) has failed at the trunk.

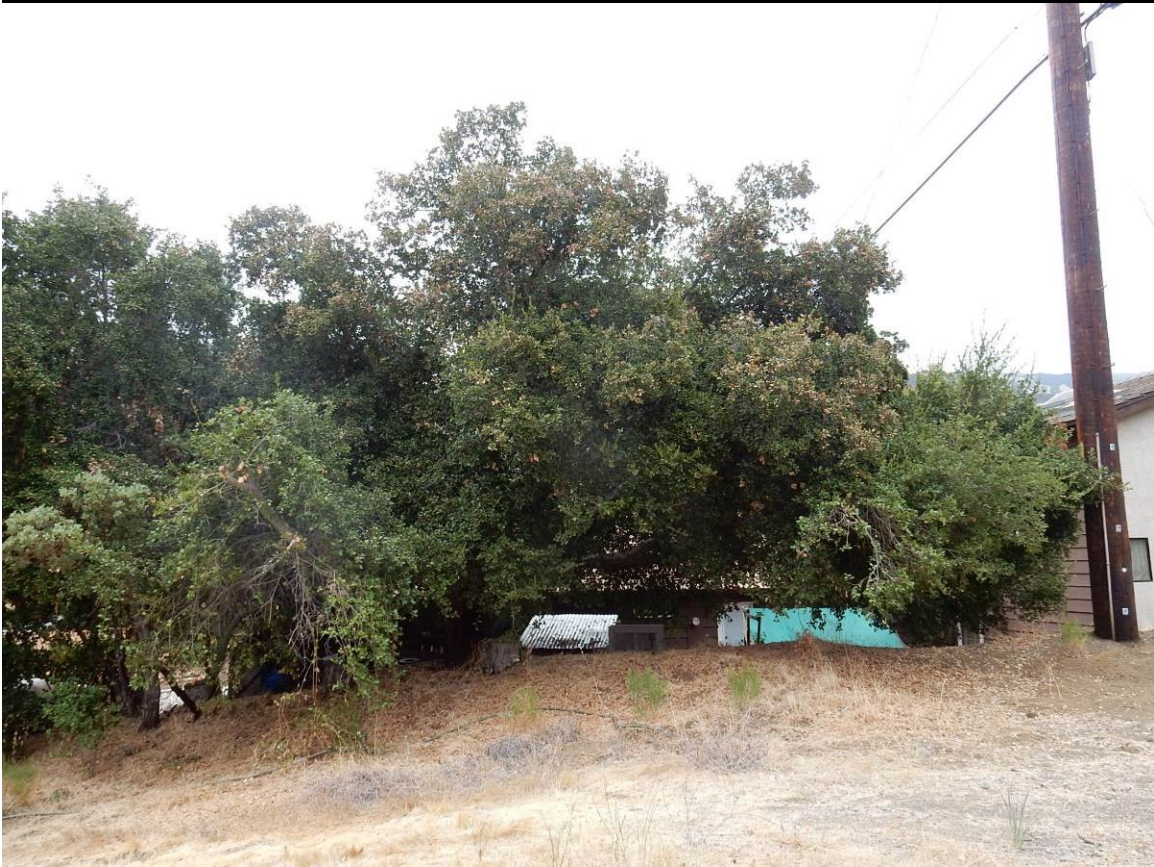
Tree #32, coast live oak (protected oak).

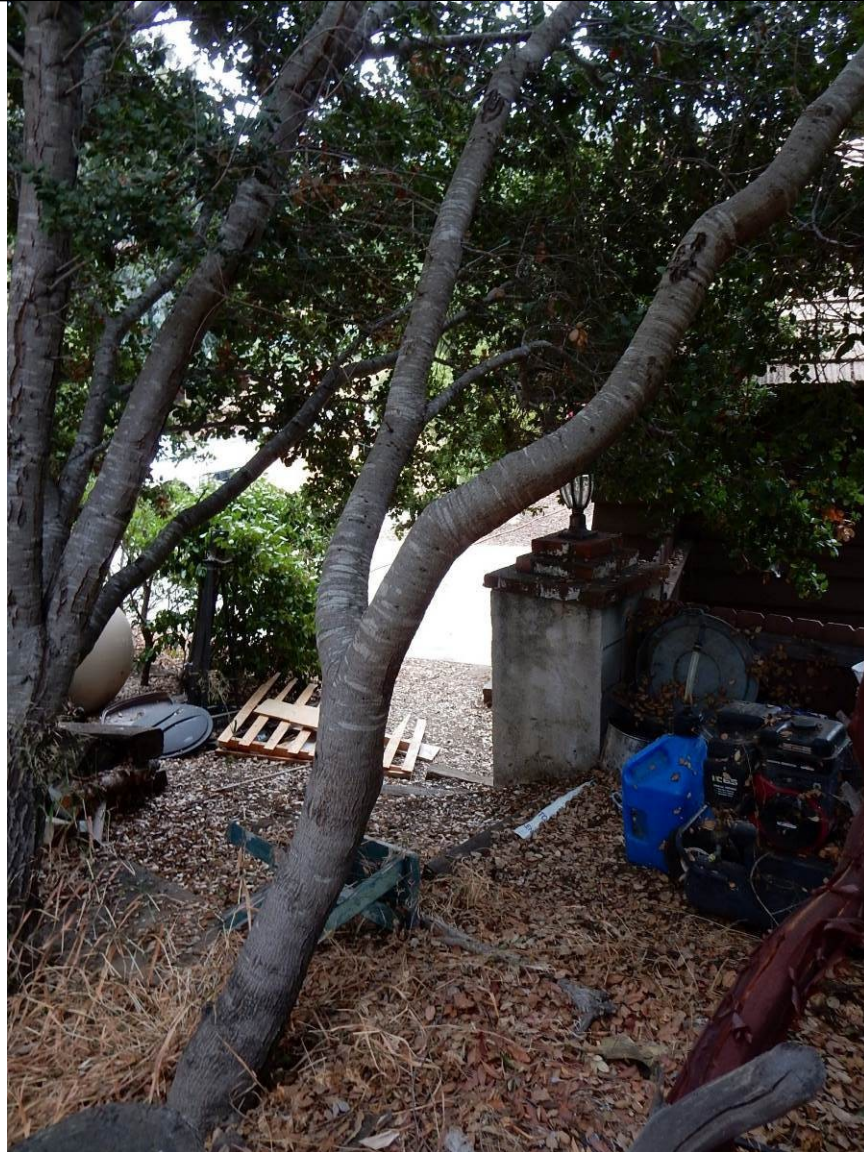
Tree #33, coast live oak (non-protected tree).

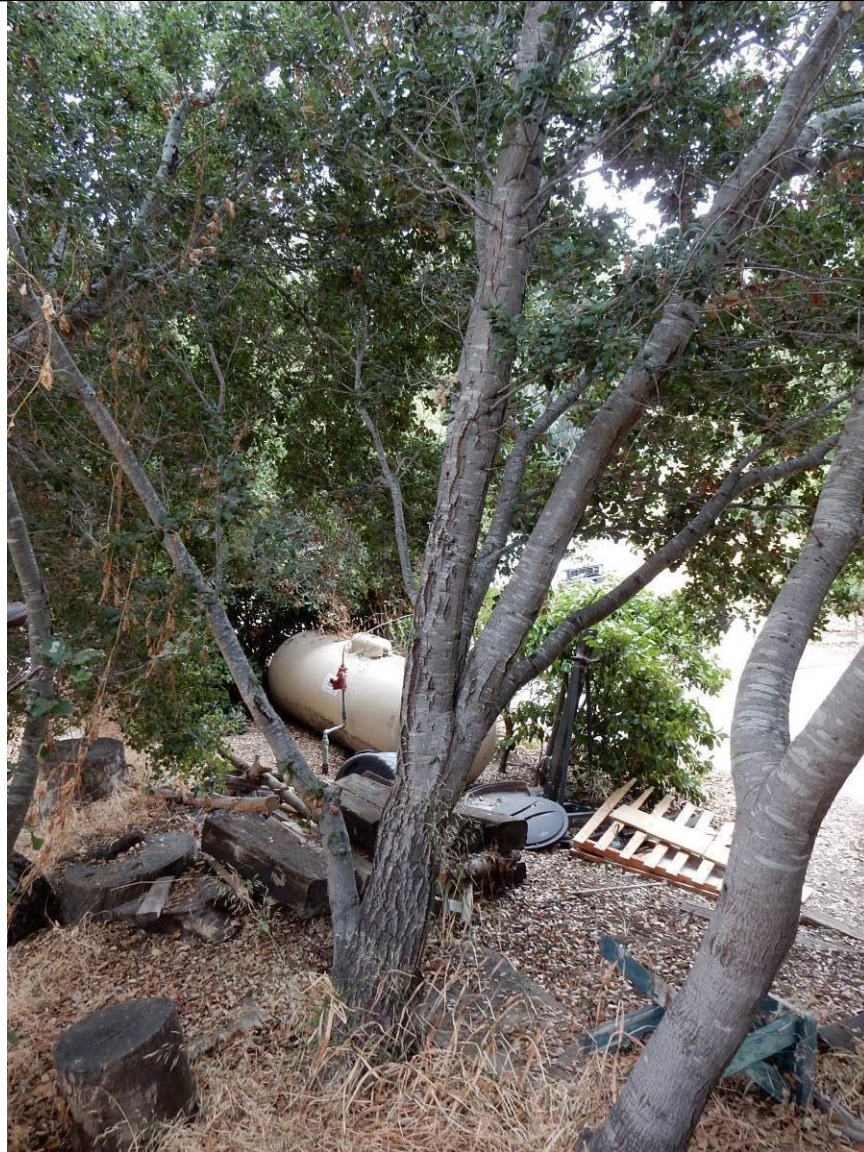
Tree #34, coast live oak (protected oak).

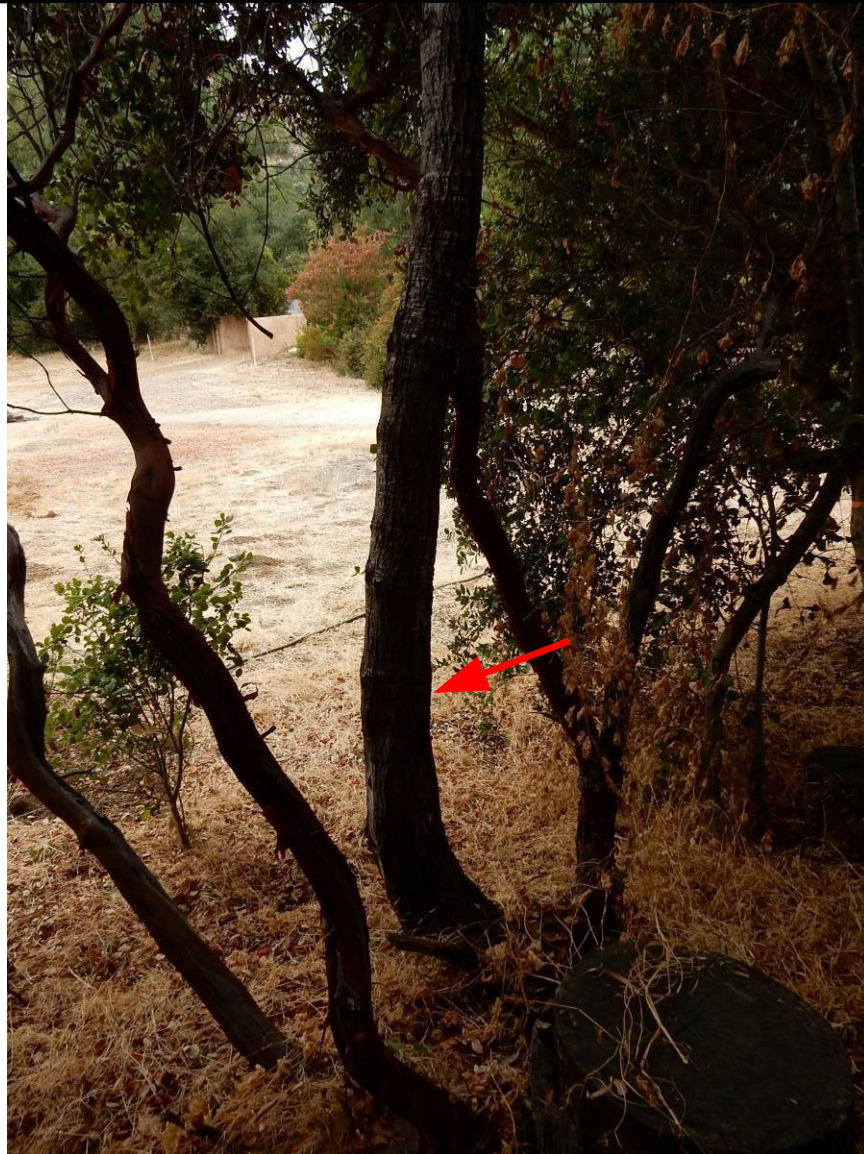
Tree #35, coast live oak (protected oak, arrow).

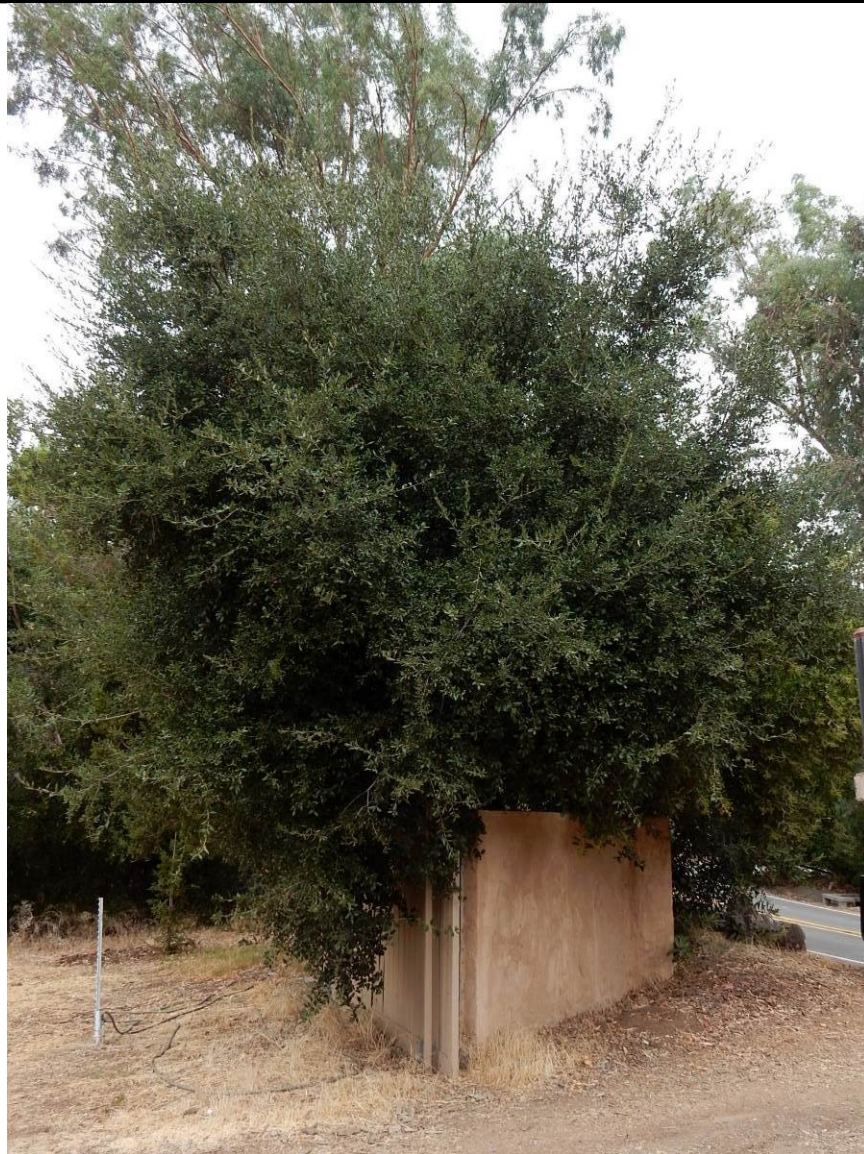
All of the possible impacts from past construction affect less than 10% of any tree's protected zone and no trees are requested for removal. **However, protected tree #38, has a previously-constructed wall that is within three feet of the trunk. The tree is in good health as of September 26, 2019 but the county may still require 10 mitigation trees. Thus, this project may require a total of 10 mitigation trees depending on the county's decision on whether the previously-constructed wall counts as an impact.**

Tree #38, coast live oak (protected oak).

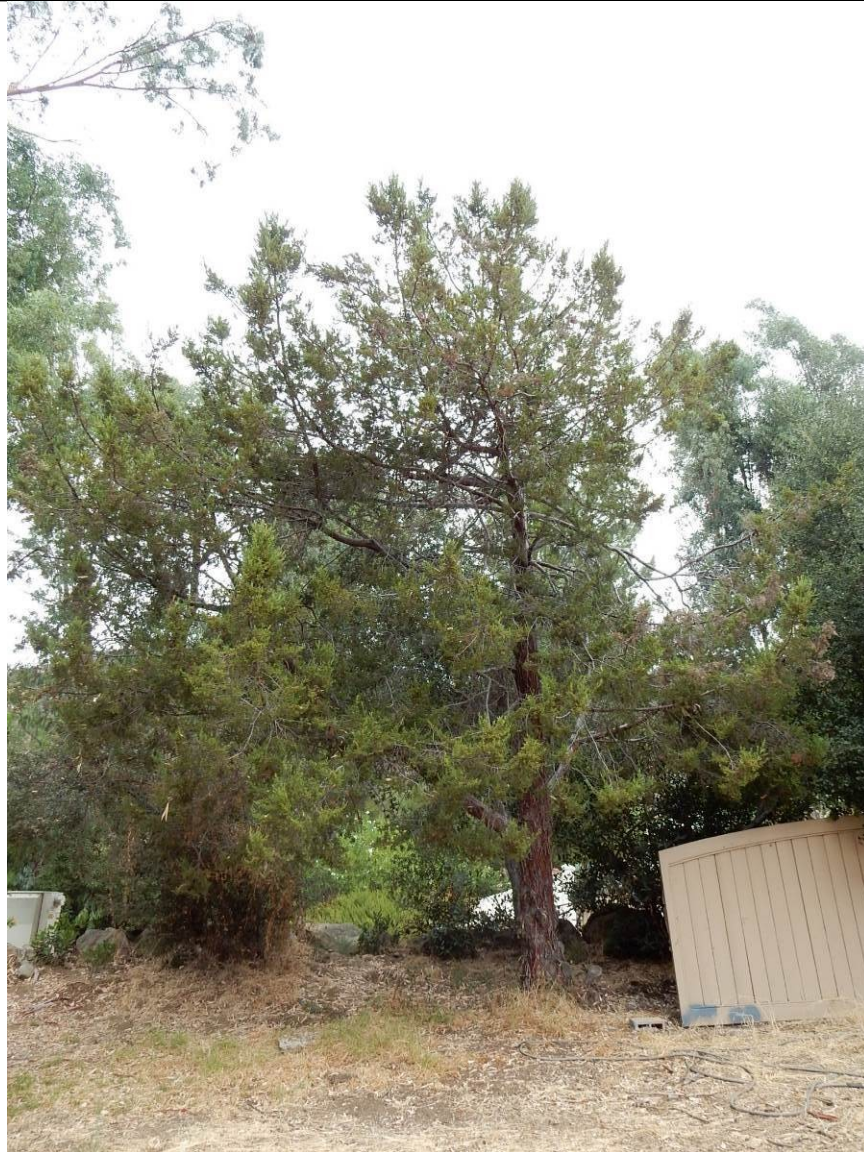
Tree #41, Arizona cypress (non-protected tree).
